**Mill Pond Dam Supplemental Site
Investigation Work Plan**

Former Georgia-Pacific Wood Products Facility
Fort Bragg, California

July 2014

Prepared by:
ARCADIS U.S., Inc.
100 Montgomery Street
Suite 300
San Francisco
California 94104
Tel 415 374 2744
Fax 415 374 2745

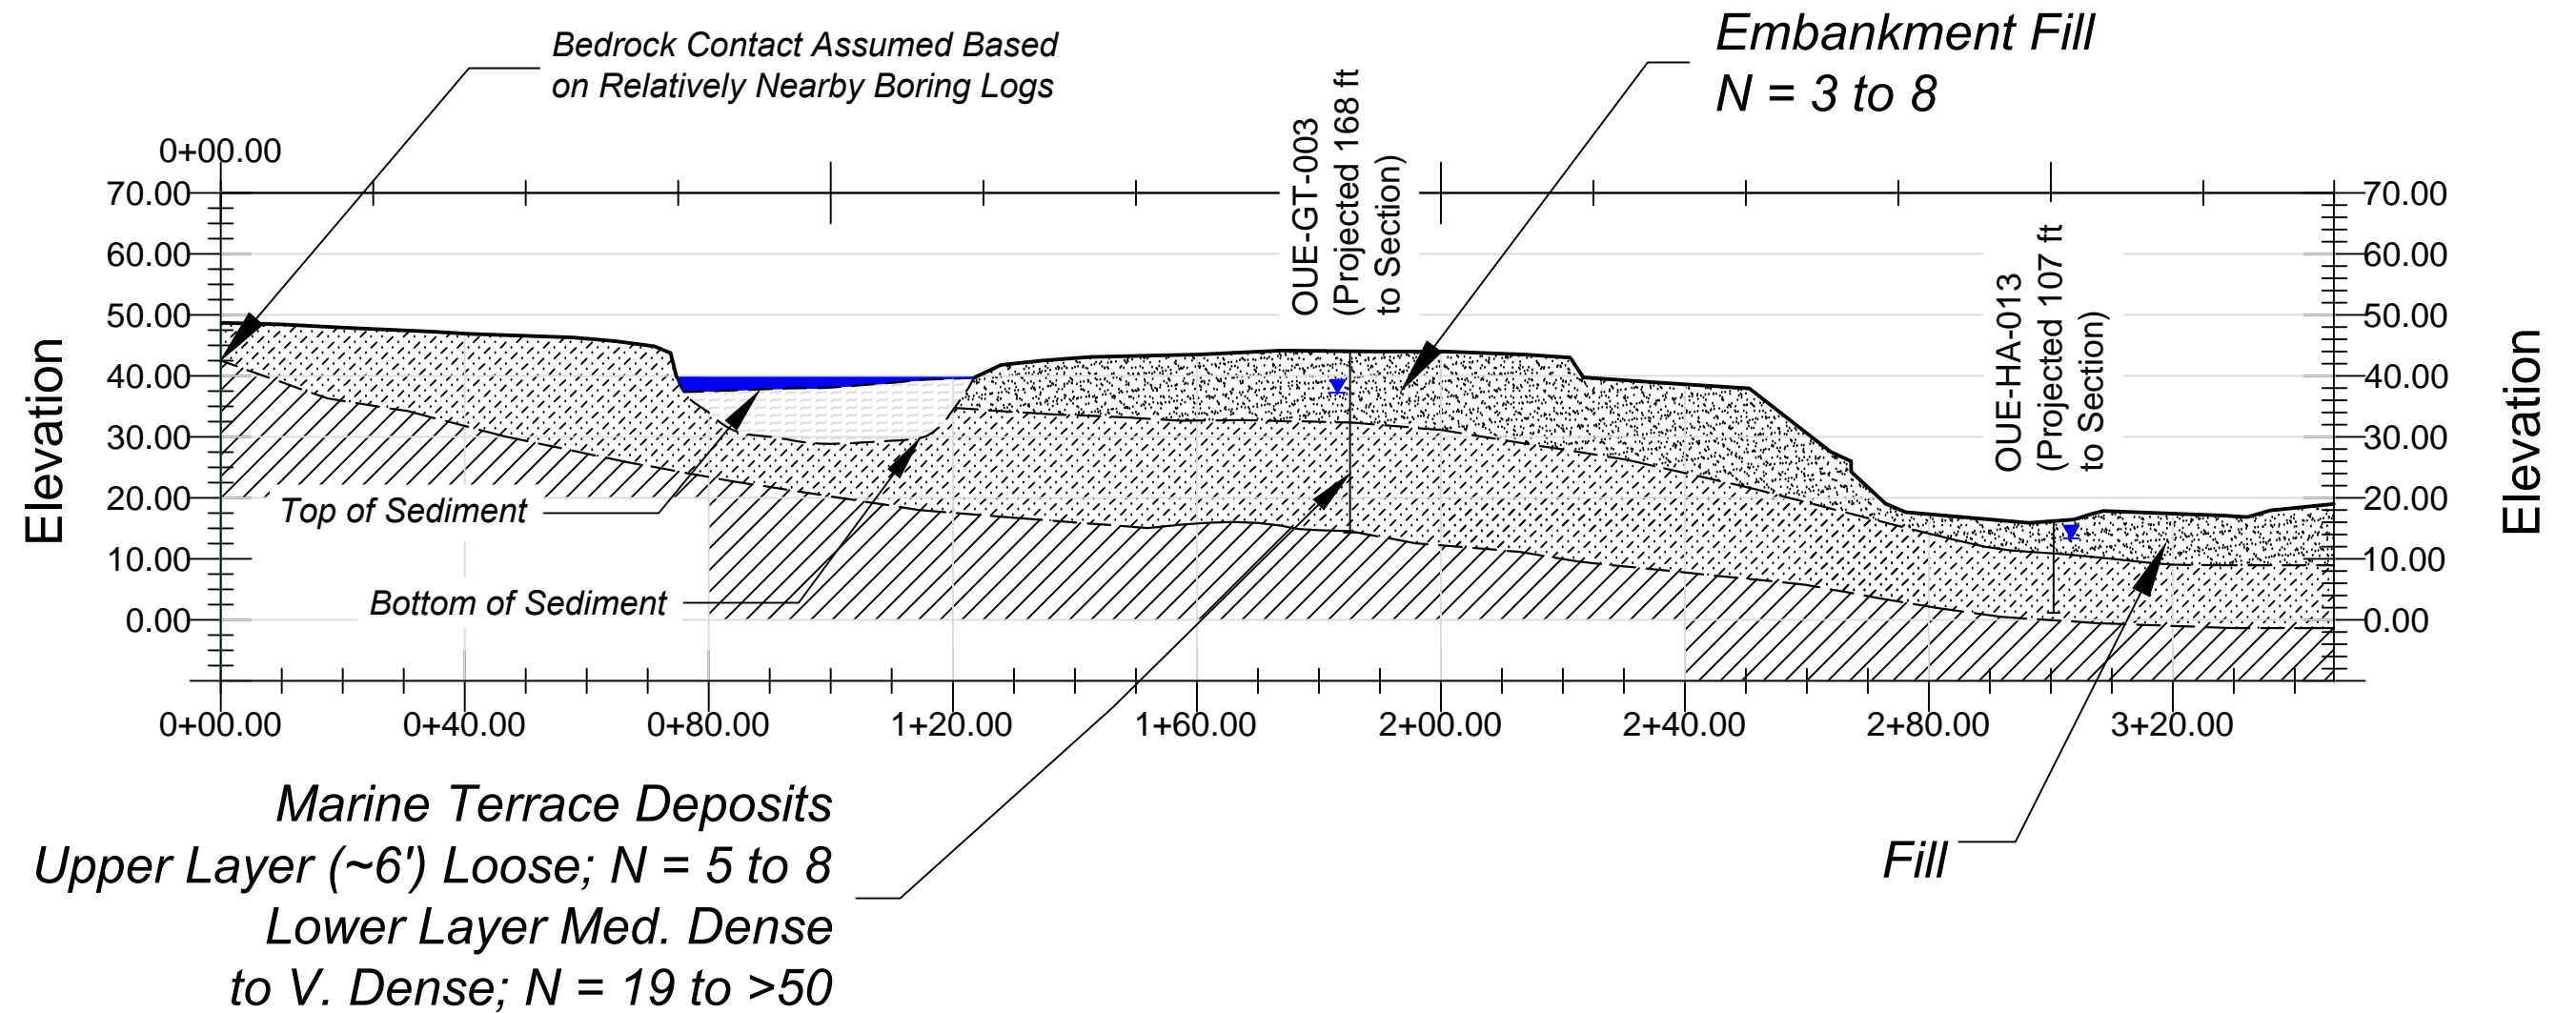
Figure 5
CENTRAL SECTION GENERALIZED GEOLOGY

Profile View of Section CC
